Flood Control Project Maintenance
2014 Structure Summary Report
Overall Unit and Item Ratings

San Joaquin County Flood Control and Water Conservation District

Duck Creek Diversion Weir And Control Structure

Flood Control Project Maintenance**Unit Cover Sheet****2014 Structure Inspection Results****San Joaquin County Flood Control and Water Conservation District**

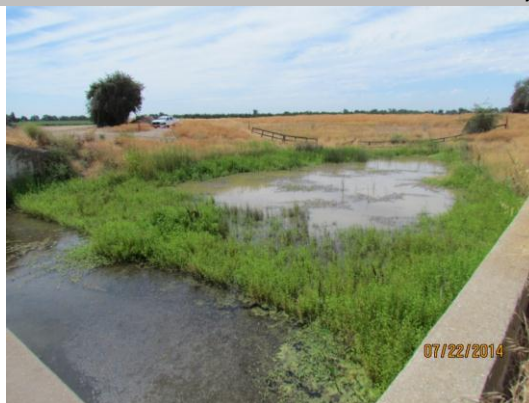
Photo 1 of 2 : ST_2014_NA0017_5_2_20140731_00009.jpg

LM Start	0.00	Rating **	A	Issue No.	2
LM End	0.00	Issue Type +	Ma	Location *	
Category	Structures & Concrete Lined Channels			GPS Latitude/Longitude	
				Start	End
Item	Vegetation & Obstructions			37.938383 °	37.938383 °
				-120.990133 °	-120.990133 °
DWR ID	DWR_NA0017_5_t_2012_2				
Action/Comments					
Inspector Comments: There was minimal vegetation around the structure. The flow was not impeded.

Vegetation around the structure looking downstream during 2014 inspection.

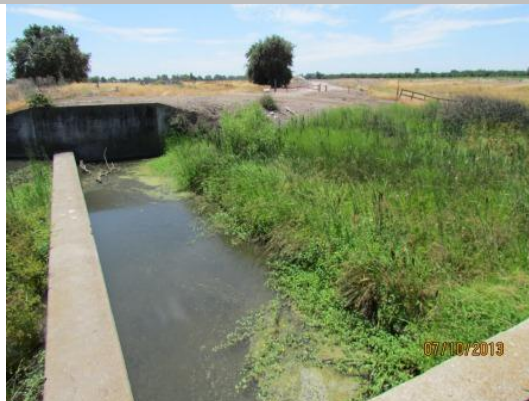
Photo 2 of 2 : ST_2014_NA0017_5_2_20140709_00001.jpg

View of the vegetation around the structure looking downstream during 2013 inspection.

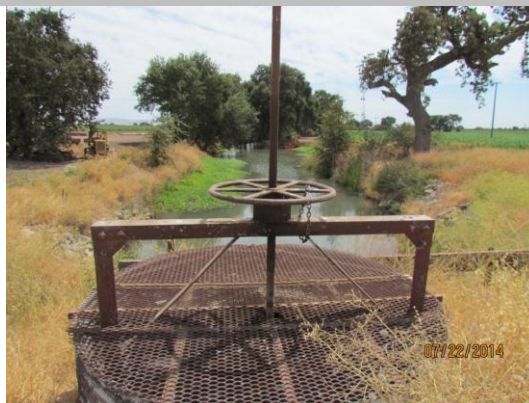
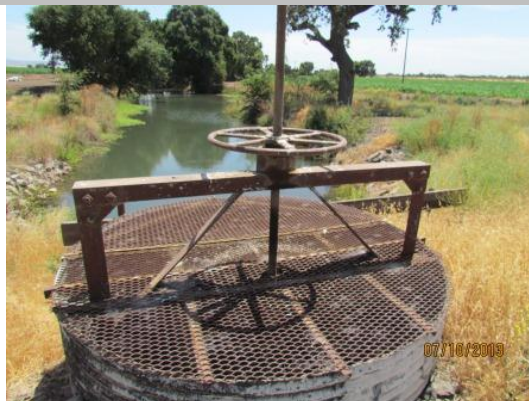
LM Start	0.00	Rating **	A	Issue No.	12
LM End	0.00	Issue Type +	Ma	Location *	
Category	Structures & Concrete Lined Channels			GPS Latitude/Longitude	
				Start	End
Item	Sluice/Slide Gates			37.938383 °	37.938383 °
				-120.990133 °	-120.990133 °
DWR ID	DWR_NA0017_5_t_2012_12				
Action/Comments					
Inspector Comments: The gates appeared to be in good working condition.

View of the slide gate during 2014 inspection.

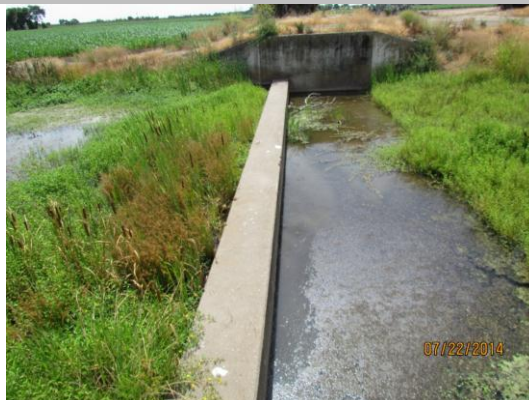
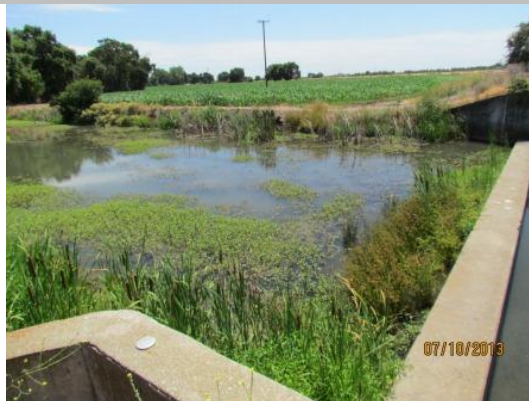
LM Start	0.00	Rating **	A	Issue No.	15
LM End	0.00	Issue Type +	Ma	Location *	
Category	Structures & Concrete Lined Channels	GPS Latitude/Longitude			
		Start		End	
Item	Concrete Surfaces	37.938383 °		37.938383 °	
		-120.990133 °		-120.990133 °	
DWR ID	DWR_NA0017_5_t_2012_15				
Action/Comments					
Inspector Comments: The concrete surfaces had minor cracking and the surface was weathered but they didn't pose any threats to the integrity of the structure.

View of the weir and the concrete surface during 2014 inspection.

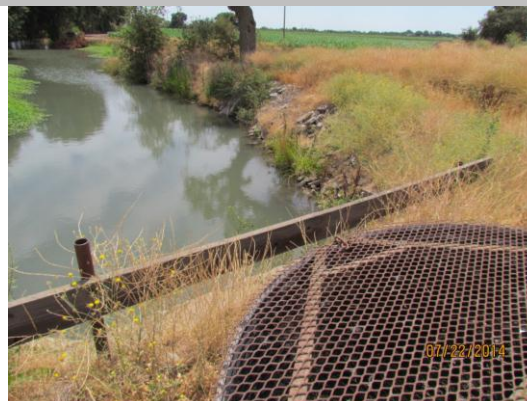
Photo 1 of 1 : ST_2014_NA0017_5_23_20140731_00015.jpg

LM Start	0.00	Rating **	A	Issue No.	23
LM End	0.00	Issue Type +	Ma	Location *	
Category	Structures & Concrete Lined Channels			GPS Latitude/Longitude	
				Start	End
Item	Safety			37.938383 °	37.938383 °
				-120.990133 °	-120.990133 °
DWR ID	DWR_NA0017_5_t_2012_23				
Action/Comments					
Inspector Comments: The wood railing top of the culvert appeared to provide adequate protection against fall hazards.

View of the railing top of the culvert.

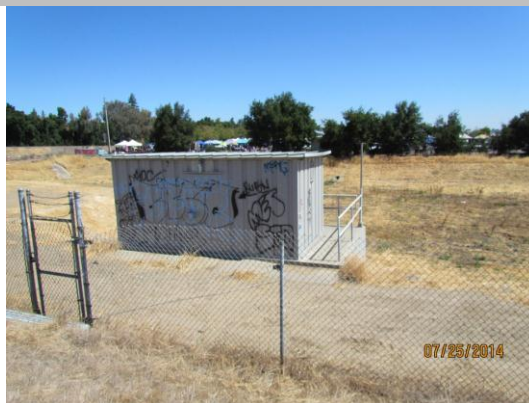
Photo 1 of 1 : ST_2014_NA0017_18_3_20140805_00013.jpg

LM Start	0.00	Rating **	A	Issue No.	3
LM End	0.00	Issue Type +	Ma	Location *	
Category	Pump Stations			GPS Latitude/Longitude	
				Start	End
Item	Plant Building			37.989633 °	37.989633 °
				-121.266933 °	-121.266933 °
DWR ID	DWR_NA0017_18_t_2012_3				
Action/Comments					
Inspector Comments: The plant building was in good structural condition.

View of the pumping plant.

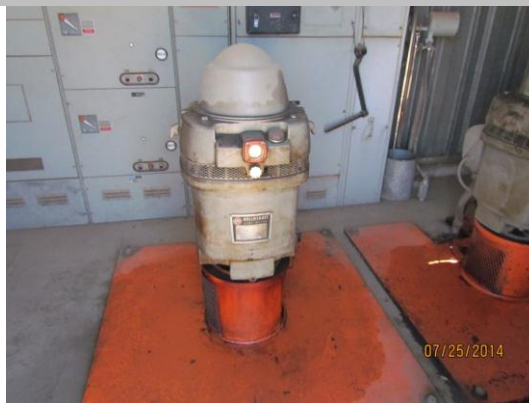
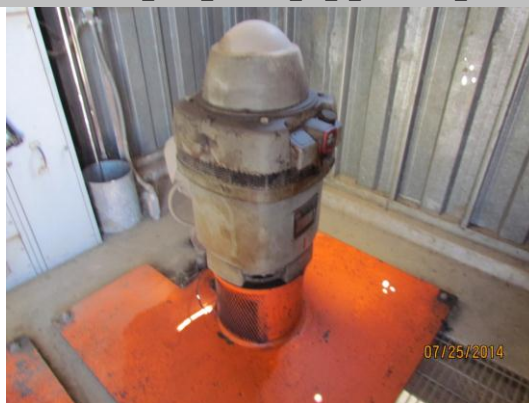
LM Start	0.00	Rating **	A	Issue No.	7
LM End	0.00	Issue Type +	Ma	Location *	
Category	Pump Stations			GPS Latitude/Longitude	
				Start	End
Item	Pumps			37.989633 °	37.989633 °
				-121.266933 °	-121.266933 °
DWR ID	DWR_NA0017_18_t_2012_7				
Action/Comments					
Inspector Comments: All pumps were appeared to be in working condition and they were maintained, lubricated and tested periodically.

View of the one of the pumps inside the plant.

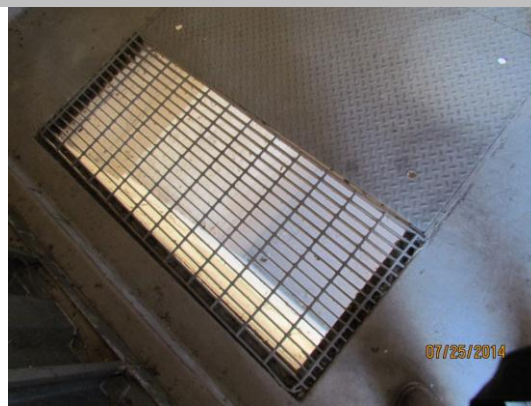
Photo 1 of 1 : ST_2014_NA0017_18_12_20140805_00019.jpg

LM Start	0.00	Rating **	A	Issue No.	12
LM End	0.00	Issue Type +	Ma	Location *	
Category	Pump Stations			GPS Latitude/Longitude	
				Start	End
Item	Sumps/Wet Well			37.989633 °	37.989633 °
				-121.266933 °	-121.266933 °
DWR ID	DWR_NA0017_18_t_2012_12				
Action/Comments					
Inspector Comments: The wet well was completely dry and very little debris was present during inspection.

View of the dry wet well.

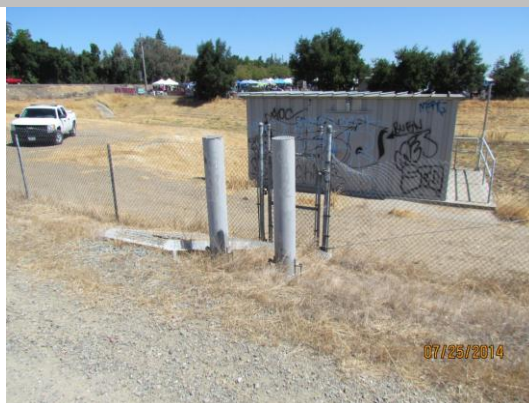
Photo 1 of 1 : ST_2014_NA0017_18_21_20140805_00023.jpg

LM Start	0.00	Rating **	M	Issue No.	21
LM End	0.00	Issue Type +	Ma	Location *	
Category	Pump Stations			GPS Latitude/Longitude	
				Start	End
Item	Security Fencing			37.989633 °	37.989633 °
				-121.266933 °	-121.266933 °
DWR ID	DWR_NA0017_18_t_2012_21				
Action/Comments					
Inspector Comments: Security fencing appeared to be in good condition.

View of the security fence around the pumping plant.

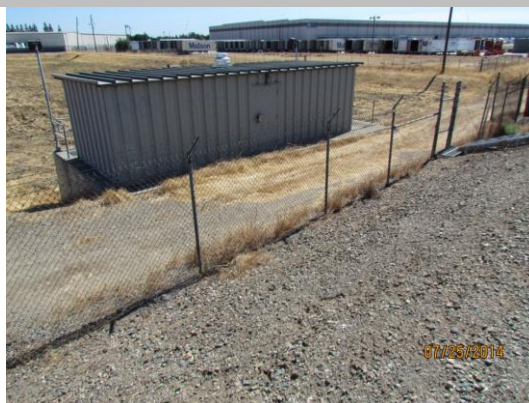
Photo 1 of 1 : ST_2014_NA0017_19_3_20140804_00012.jpg

LM Start	0.00	Rating **	A	Issue No.	3
LM End	0.00	Issue Type +	Ma	Location *	
Category	Pump Stations			GPS Latitude/Longitude	
				Start	End
Item	Plant Building			37.982317 °	37.982317 °
				-121.249433 °	-121.249433 °
DWR ID	DWR_NA0017_19_t_2012_3				
Action/Comments					
Inspector Comments: The plant building was in good structural condition without any major cracks in the concrete.

View of the pumping plant.

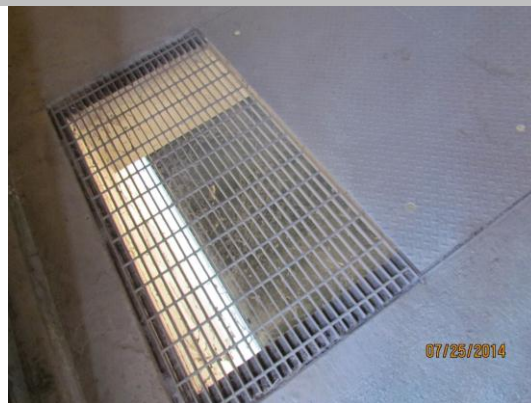
Photo 1 of 1 : ST_2014_NA0017_19_12_20140804_00016.jpg

LM Start	0.00	Rating **	A	Issue No.	12
LM End	0.00	Issue Type +	Ma	Location *	
Category	Pump Stations			GPS Latitude/Longitude	
				Start	End
Item	Sumps/Wet Well			37.982317 °	37.982317 °
				-121.249433 °	-121.249433 °
DWR ID	DWR_NA0017_19_t_2012_12				
Action/Comments					
Inspector Comments: The wet well appeared to be clear of excessive debris or sediments.

View of the wet well.

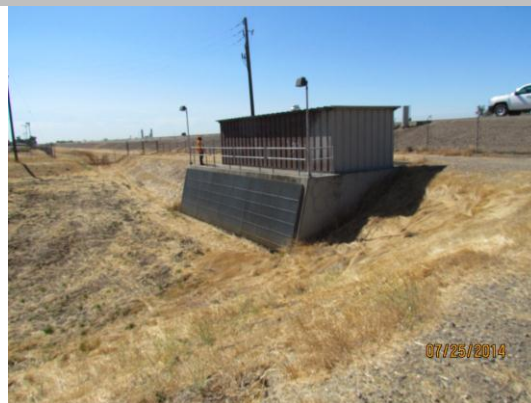
Photo 1 of 1 : ST_2014_NA0017_19_13_20140804_00017.jpg

LM Start	0.00	Rating **	A	Issue No.	13
LM End	0.00	Issue Type +	Ma	Location *	
Category	Pump Stations			GPS Latitude/Longitude	
				Start	End
Item	Trash Racks			37.982317 °	37.982317 °
				-121.249433 °	-121.249433 °
DWR ID	DWR_NA0017_19_t_2012_13				
Action/Comments					
Inspector Comments: Trash racks were properly maintained and free of any debris.

View of the trash racks.

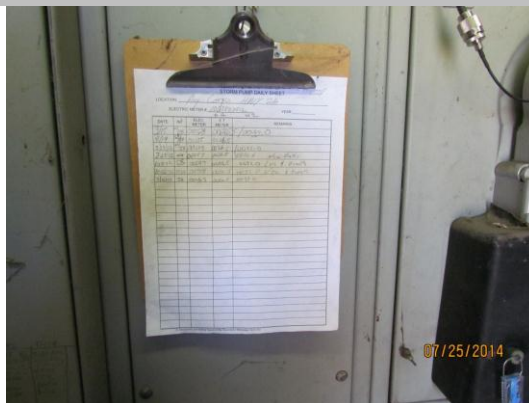
Photo 1 of 1 : ST_2014_NA0017_20_1_20140801_00011.jpg

View of the operating log inside the pumping plant, but the log didn't appear to be up to date.
